GENESEE LAKES OUTLET PIPE

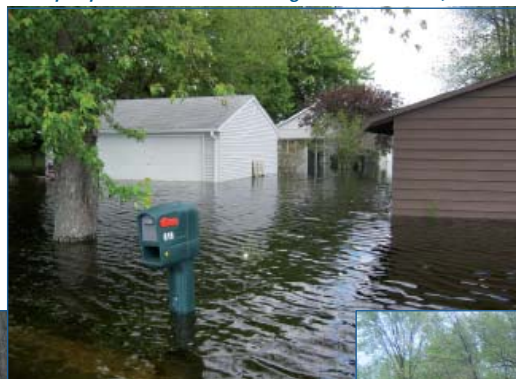
Flooded properties in the Village of Summit (June, 2008)

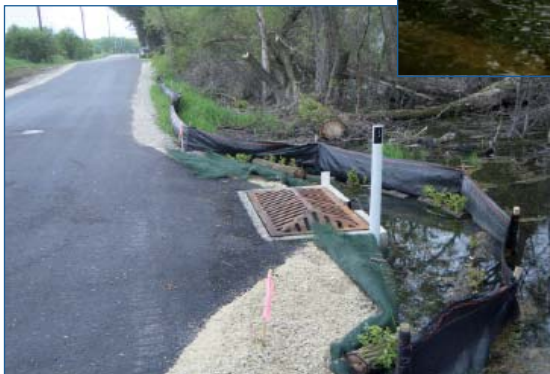
Water from lowlands enters outlet structure at Lower Lake Road

Yaggy Colby designed an outlet structure and pipe to carry overflow from Lower Genesee Lake, which would provide a controlled elevation for all three lakes and prevent future flooding. Water from the lake system overflows through lowlands to Lower Lake Road, where it now enters the new outlet structure. Via gravity, it travels about one mile through an 18-inch discharge pipe. The water exits the pipe to a swale area, and then enters an area of wetlands where it drains to the Bark River. As part of the design, the firm had to analyze the outlet structure's downstream impacts to the Bark River to ensure that the design did not raise the floodplain elevation by more than 0.01 feet.

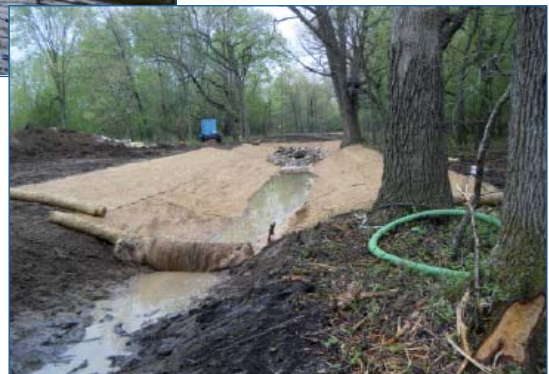
Water leaves outlet pipe through discharge point and swale (shown under construction)
